REPAIR EVALUATIONS OF DEPRESSED TRANSVERSE CRACKS IN ASPHALT PAVEMENTS IN DISTRICT 6

FINAL REPORT

ODOT TASK ORDER NUMBER 2160-20-02

August 2021

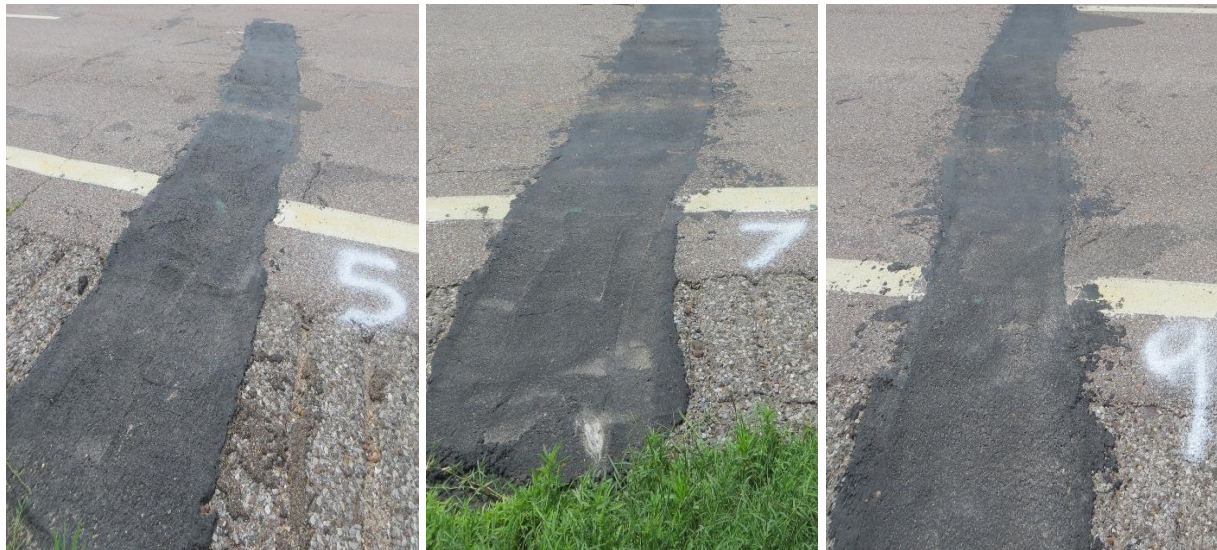
Figure 3.1 Photographs of Fibrecrete-repaired cracks during Evaluation #3: (a) Crack #5; (b) Crack #7; and (c) Crack #9

Figures 3.1, 3.2 and 3.3 show the photographs of Fibrecrete-repaired, HMA-repaired and control section, respectively. From physical inspection, the Fibrecrete-repaired sections were found to perform better as compared to HMA-repaired sections. No reflective cracking was observed in the Fibrecrete-repaired sections during after repair evaluations, i.e., Evaluation #2 and #3. However, during Evaluation #3 (11-months after repair), reflective cracks were found in all three HMA-repaired sections, as shown in Figures 3.2 (a), 3.2 (b) and 3.2 (c). Also, cracking along the edges of HMA-repaired sections were observed during Evaluation #3. However, no

significant changes in the crack geometry over time were observed for the control cracks (Figure 3.3).

- i. The physical inspection and GPR results indicated that the propagation of the underlying cracks was fully suppressed by the use of the Fibrecrete layer.

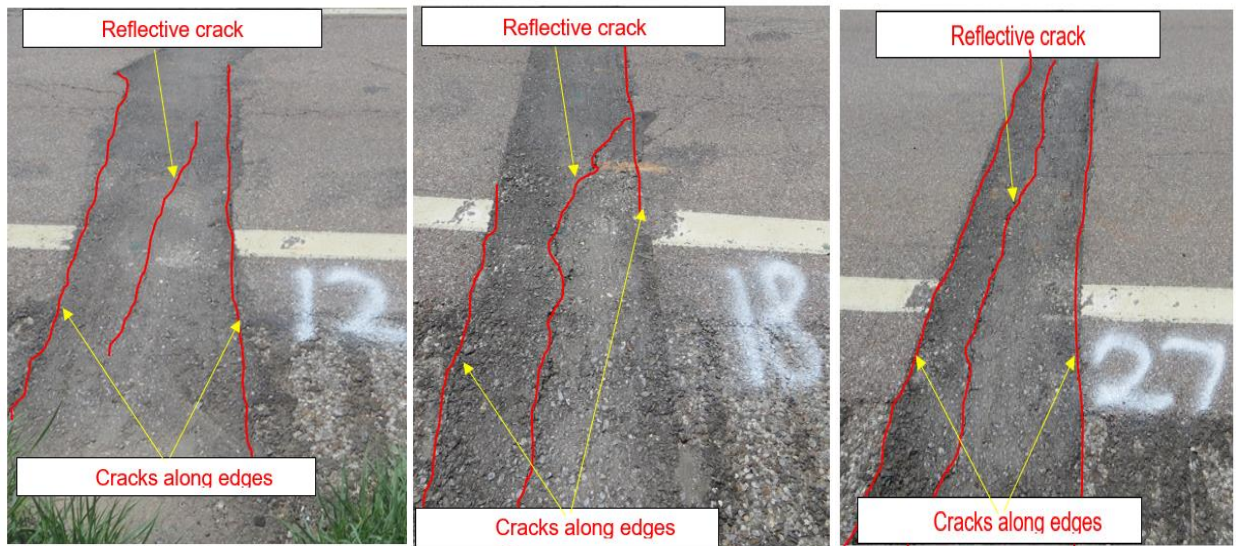
Figure 3.2 Photographs of HMA-repaired cracks during Evaluation #3: (a) Crack #12; (b) Crack #18; and (c) Crack #27

- ii. Repair with coarse HMA with no tack coat may not produce satisfactory results. Typically, the rate of the propagation of reflective cracking in HMA layer is 1-in. per year. However, for the studied sections, reflective cracks were found to propagate 2-in. in one year through the HMA layer. The use of coarse (S3) HMA may be responsible for this faster propagation of cracks. Additional cracking may have occurred due to no tack coat.

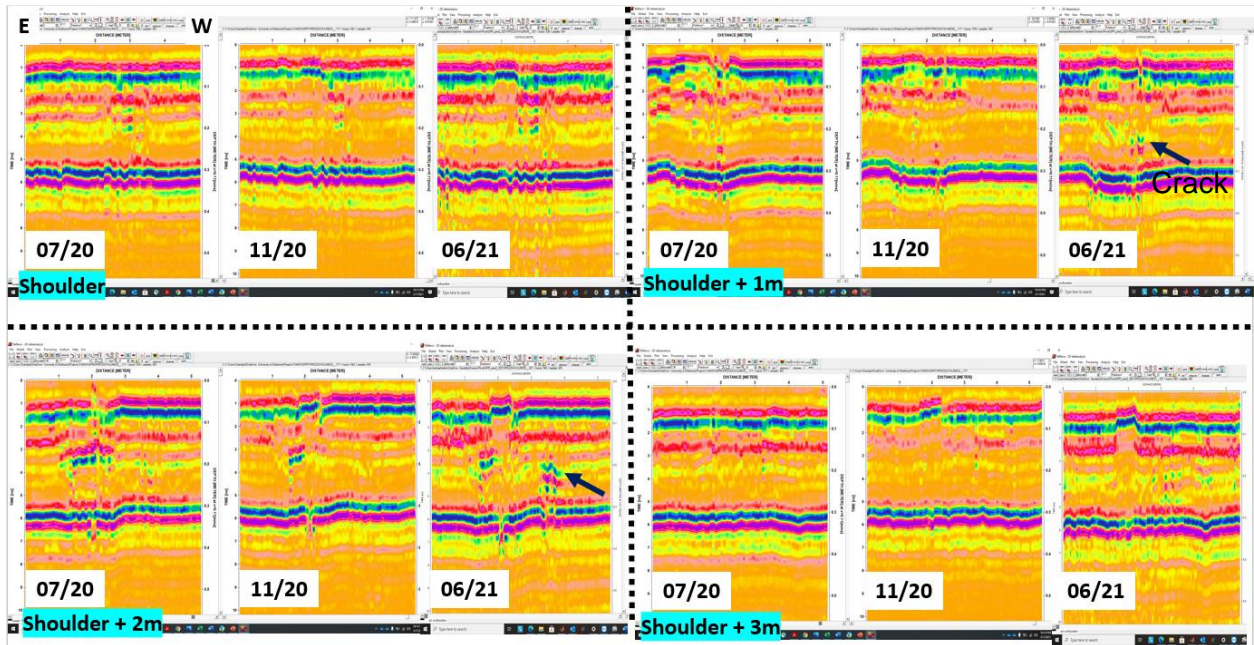
Figure 3.4 Longitudinal profile near the Crack #5 (Fibrecrete repair)

Figures 3.4, 3.5 and 3.6 show the GPR test results of Cracks #5, #12 and #30, respectively. As shown in Figure 3.4, the Fibrecrete repaired sections did not exhibit any new surface crack. Also, the propagation of the underlying transverse cracks was observed to stop due to the use of the Fibrecrete layer. However, from the GPR analyses, the HMA repaired sections were found to exhibit the propagation of the reflective cracks. For example, for Crack #12 (Figure 3.5), the presence of the reflective cracking in the HMA layer was prominent in Evaluation #3. As observed during physical inspection, these cracks already propagated through the HMA sections and edges between the new and existing HMA. Figure 3.6 presents the profiles of non-repaired (control) cracked section (Crack #30). Similar to physical inspection, the GPR analyses revealed no significant changes in the crack geometry over time for the control cracks. Additional results of the GPR tests can be found in Appendix B.

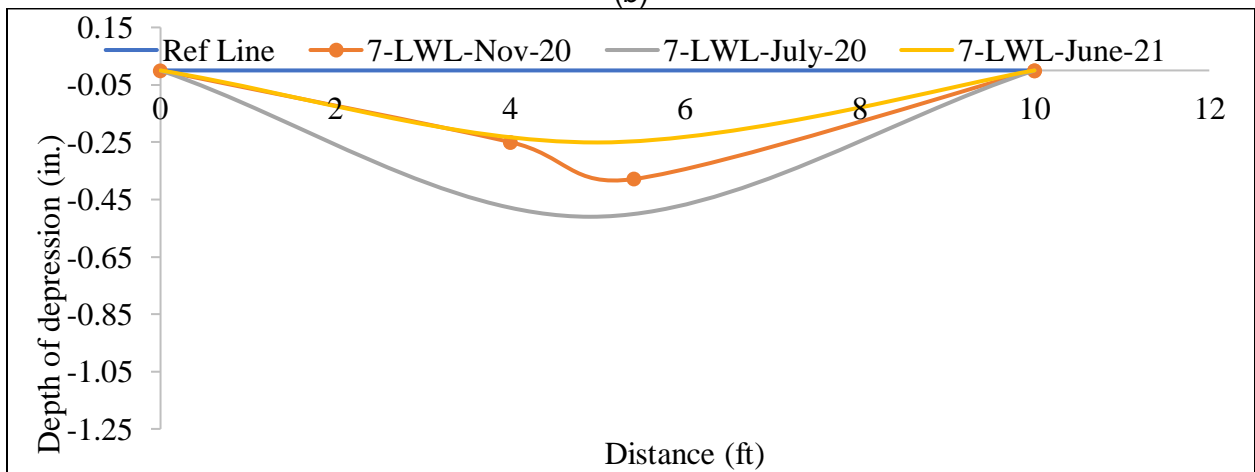
Figure 3.9 Straightedge measurements at Crack #7: (a) transverse profile; (b) longitudinal profile along right wheel-path; and (c) longitudinal profile along left wheel-path

Figures 3.9, 3.10 and 3.11 show the transverse and longitudinal (right and left wheel paths) profiles of Crack #7 (Fibrecrete-repaired), #18 (HMA-repaired) and #32 (control), respectively. The profiles of all the cracks can be found in Appendix D. By comparing the straightedge measurements of different sections, it was found that the Fibrecrete-repaired sections performed well as compared to the HMA-repaired and control sections. Deflections or depressions in both transverse and longitudinal directions were found to decrease after repairing with Fibrecrete, as evident in Figures 3.9 (a), (b) and (c). However, as shown in Figure 3.10 (a), with time, the surface deflections in the transvers direction increased for the HMA-repaired section. Also, deflections for the control sections were not found to change significantly after 11-months of repair, as shown in Figure 3.11.
