# MONITORING OF UHPC CONNECTIONS ON EUFAULA SPILLWAY BRIDGE

## FINAL REPORT

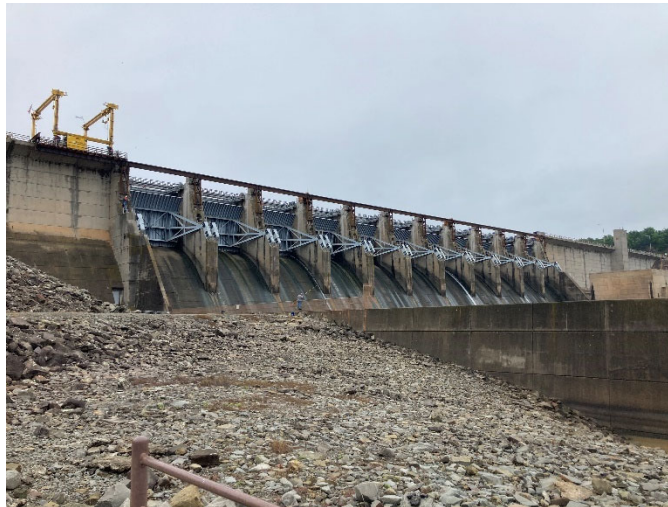
Figure 1. Lake Eufaula spillway after demolition of existing bridge

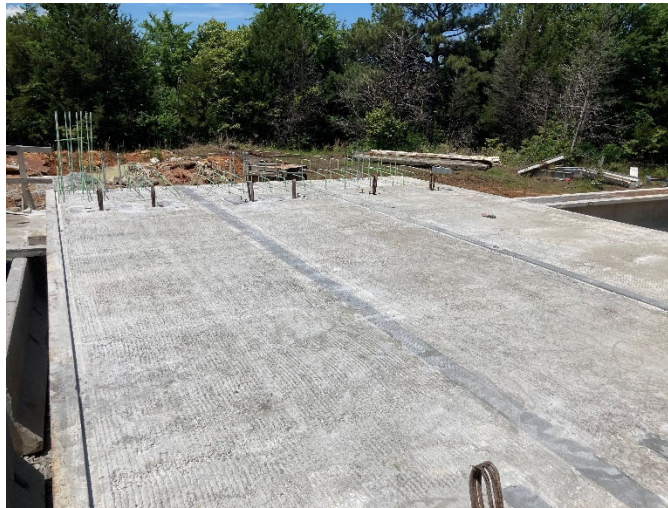
Figure 2. Overall view of the bridge deck mock-up

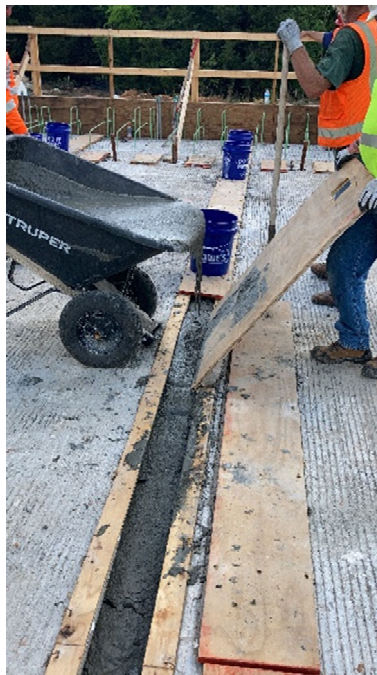
Figure 10. Top formwork placed on completed UHPC placement and head buckets in place

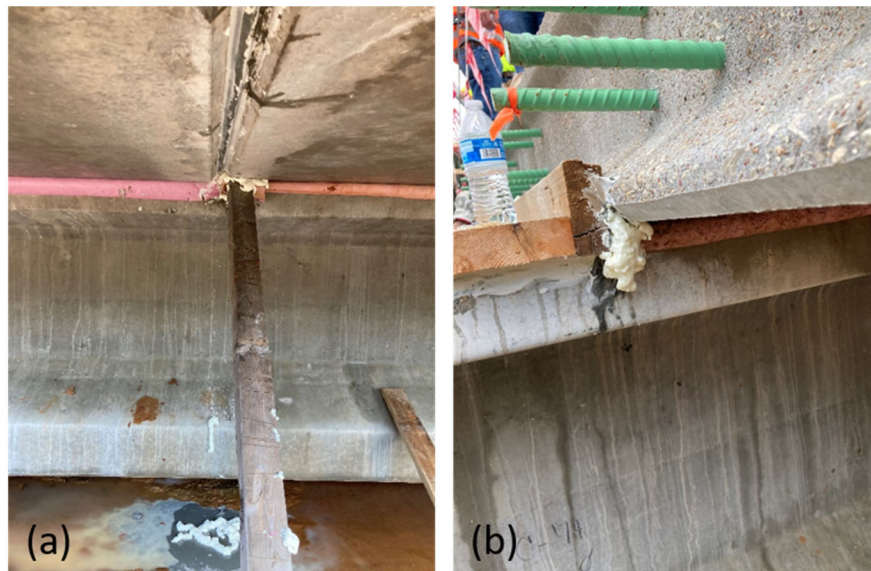
Figure 11. Bracing and spray foam utilized to stop a leak at a (a) deck joint to girder intersection and (b) end of the haunch

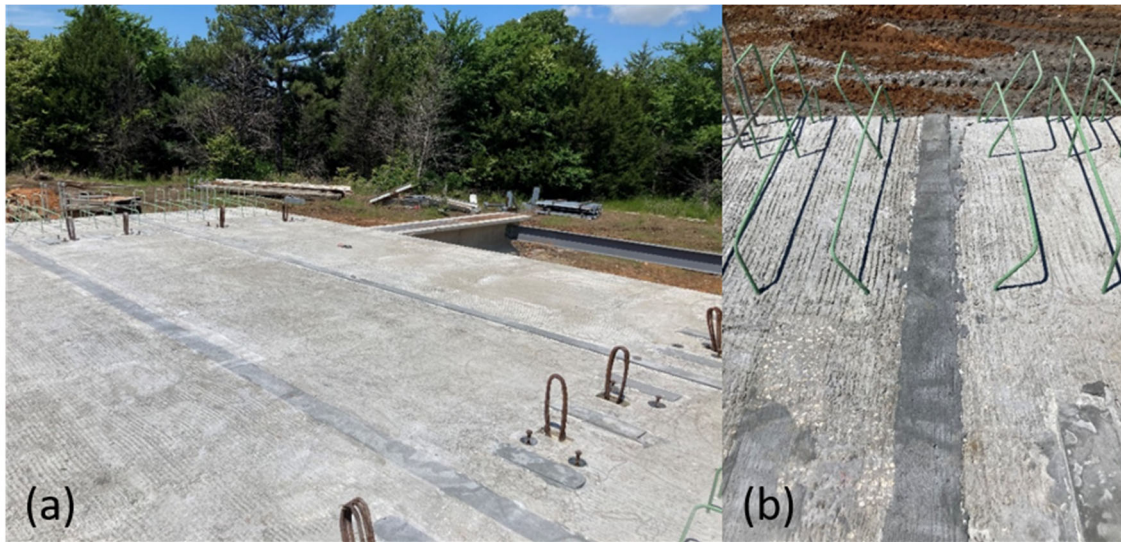
Figure 12. (a) Overall view of the mock-up joints and (b) close-up view of one joint and two shear pockets near the sidewalk and guardrail location

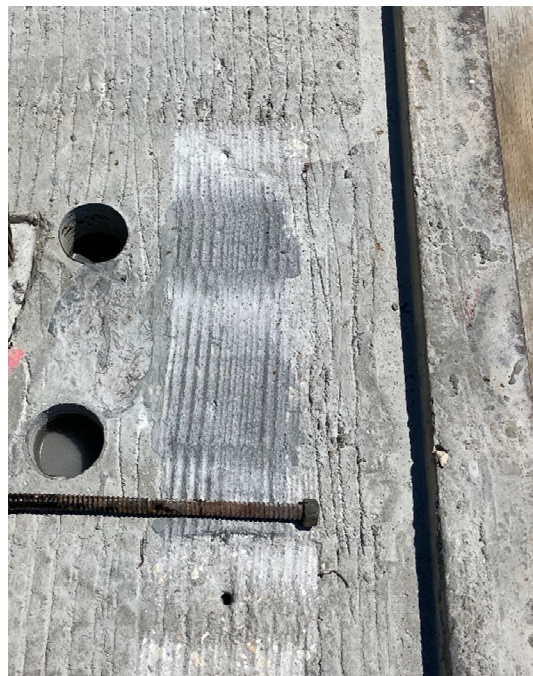
Figure 13. Close-up view of ground UHPC shear pocket to show texture after grinding

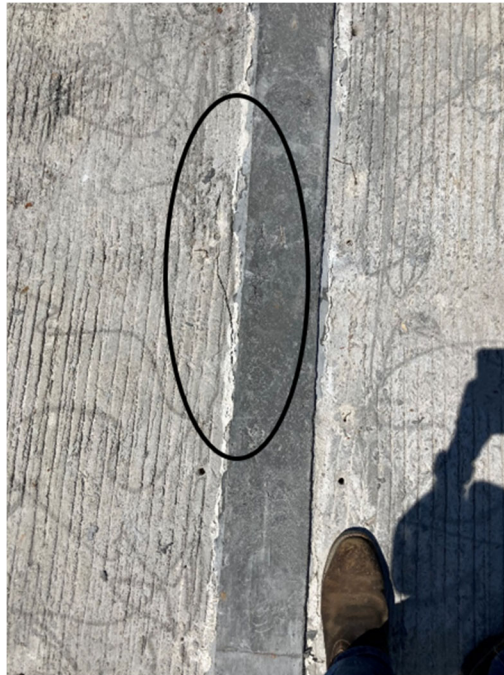
Figure 14. Crack alongside UHPC joint caused by formwork anchors

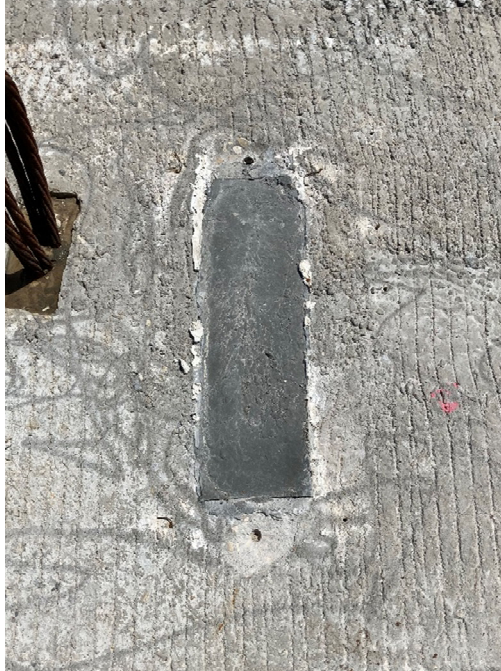
Figure 15. Close-up view of a shear pocket where the UHPC did not extend above the top of the slab as intended

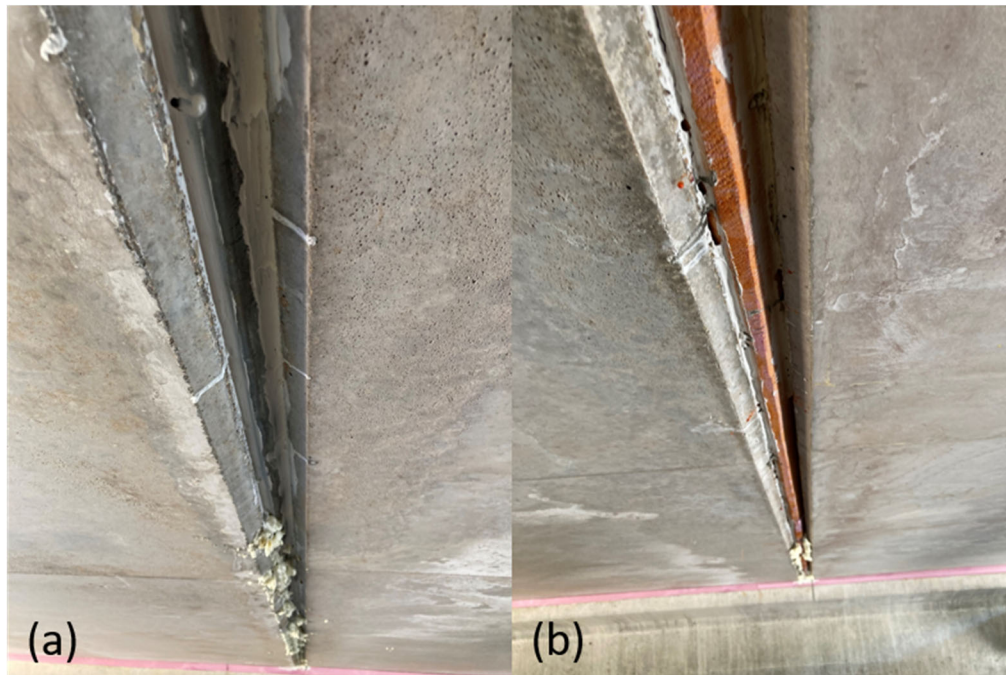
Figure 17. Of joint formwork bottom materials used in the mockup (a) steel angle and (b) pink insulation foam cut into a wedge shape

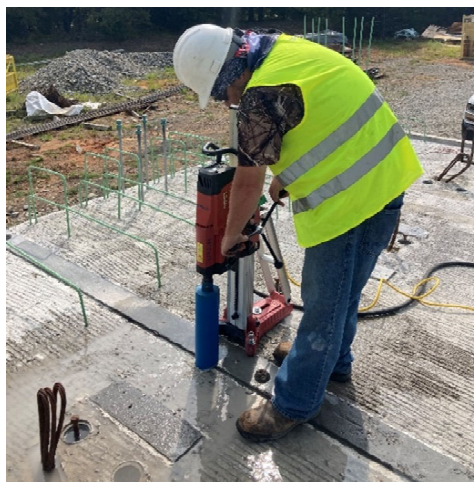
Figure 19. Coring of the bridge mock-up at the joint interface

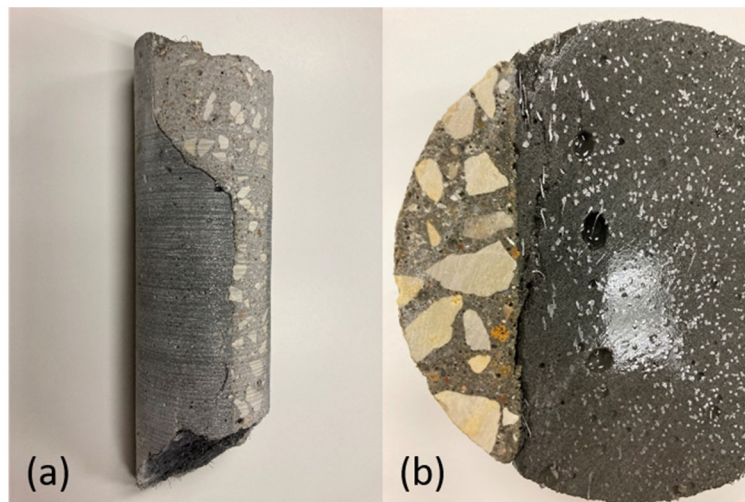
Figure 20. Core 1 taken from the UHPC to deck concrete interface showing (a) the separation at the UHPC to deck concrete interface and (b) a section through that interface (right)

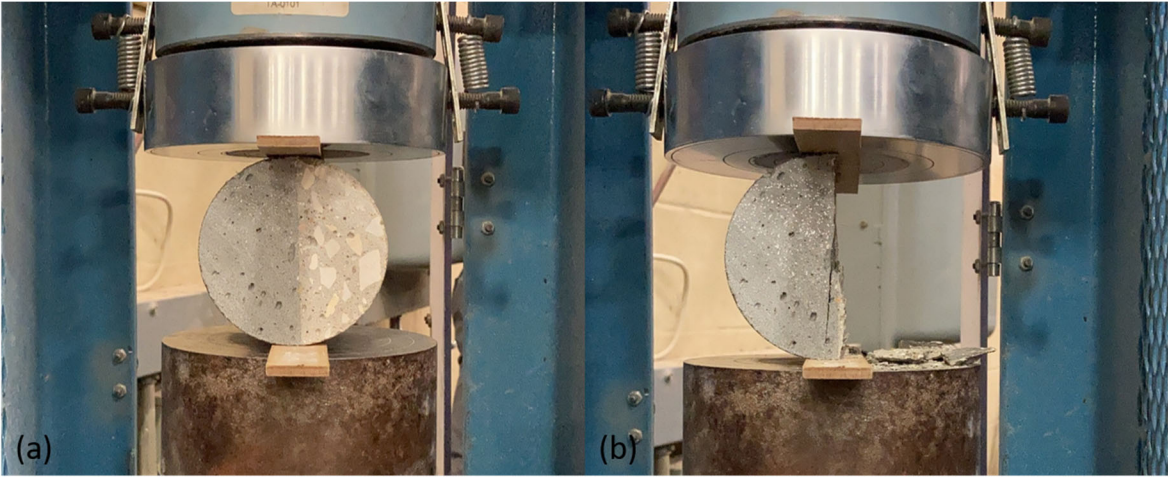
Figure 23. Interface core (Core 3) splitting tensile strength specimen (a) during test and (b) at failure

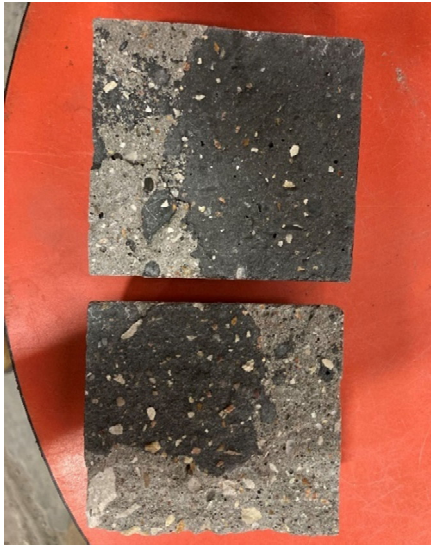
Figure 24. Core used to test strength of the conventional concrete to UHPC interface after testing

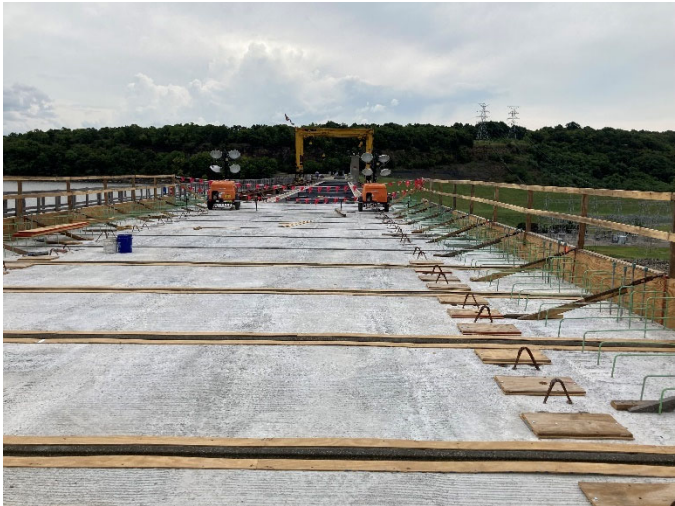
Figure 25. Bridge deck immediately before Span 1 joint placement

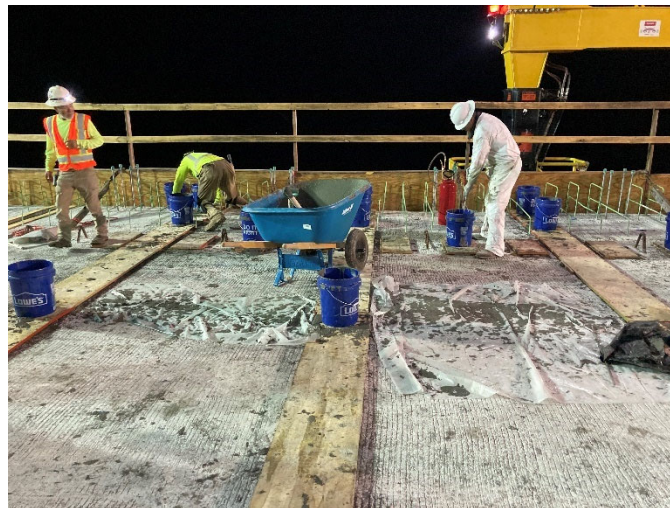
Figure 32. Placement of UHPC into the head buckets on the joint top formwork

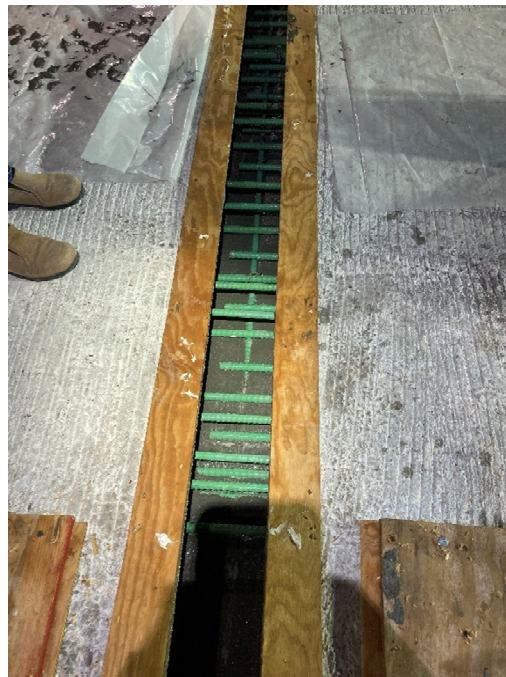
Figure 33. UHPC in one of the joints on Span 1

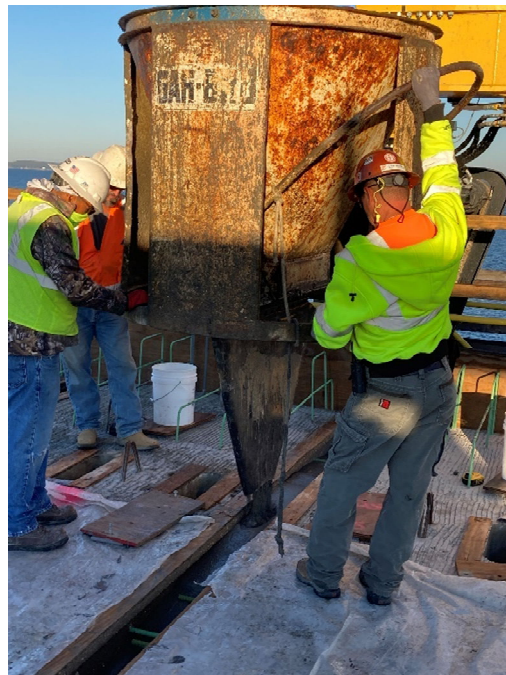
Figure 36. Placement of UHPC using the concrete transfer bucket and rubber sleeve

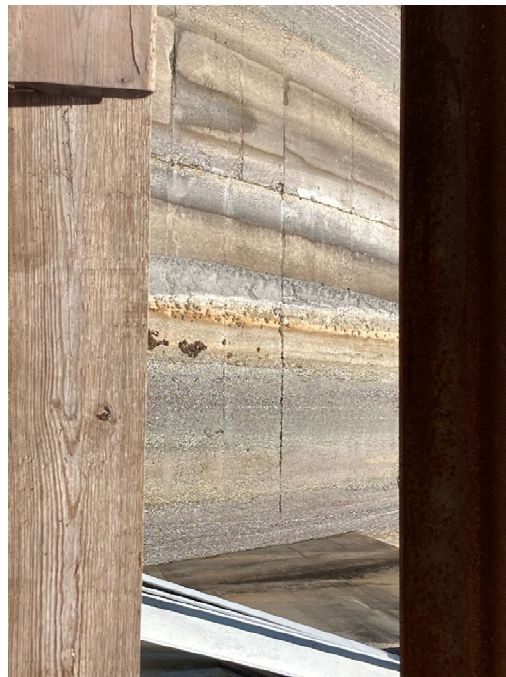
Figure 37. UHPC material from formwork blowout remaining on concrete spillway channel

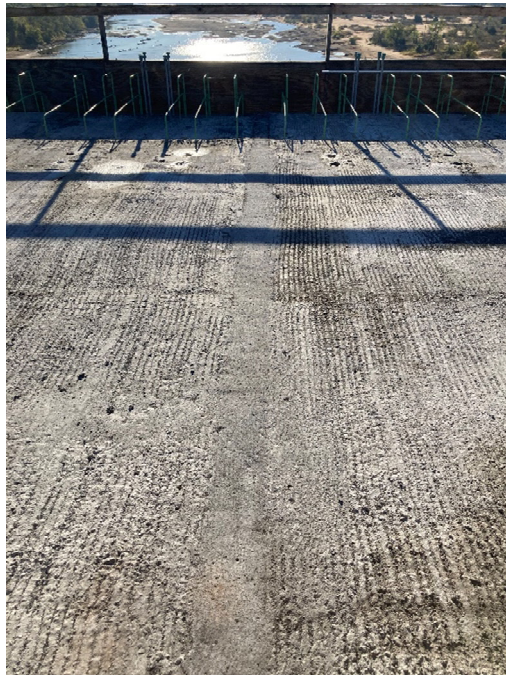
Figure 38. Example completed UHPC joint

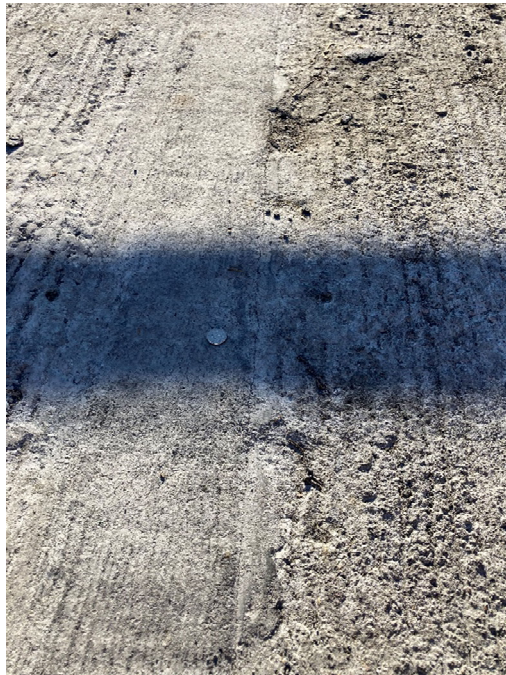
Figure 40. Crack at interface of UHPC joint and precast deck panel on Span 2 (quarter provided for scale)

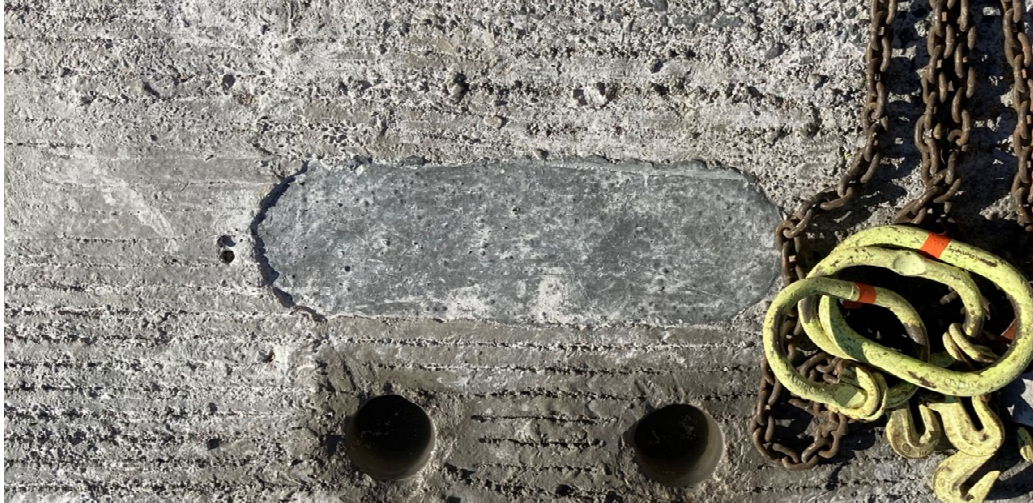
Figure 41. Shear pocket that was not filled above the level of the top of the deck
