Introduction

Background

Corrosion Assessment

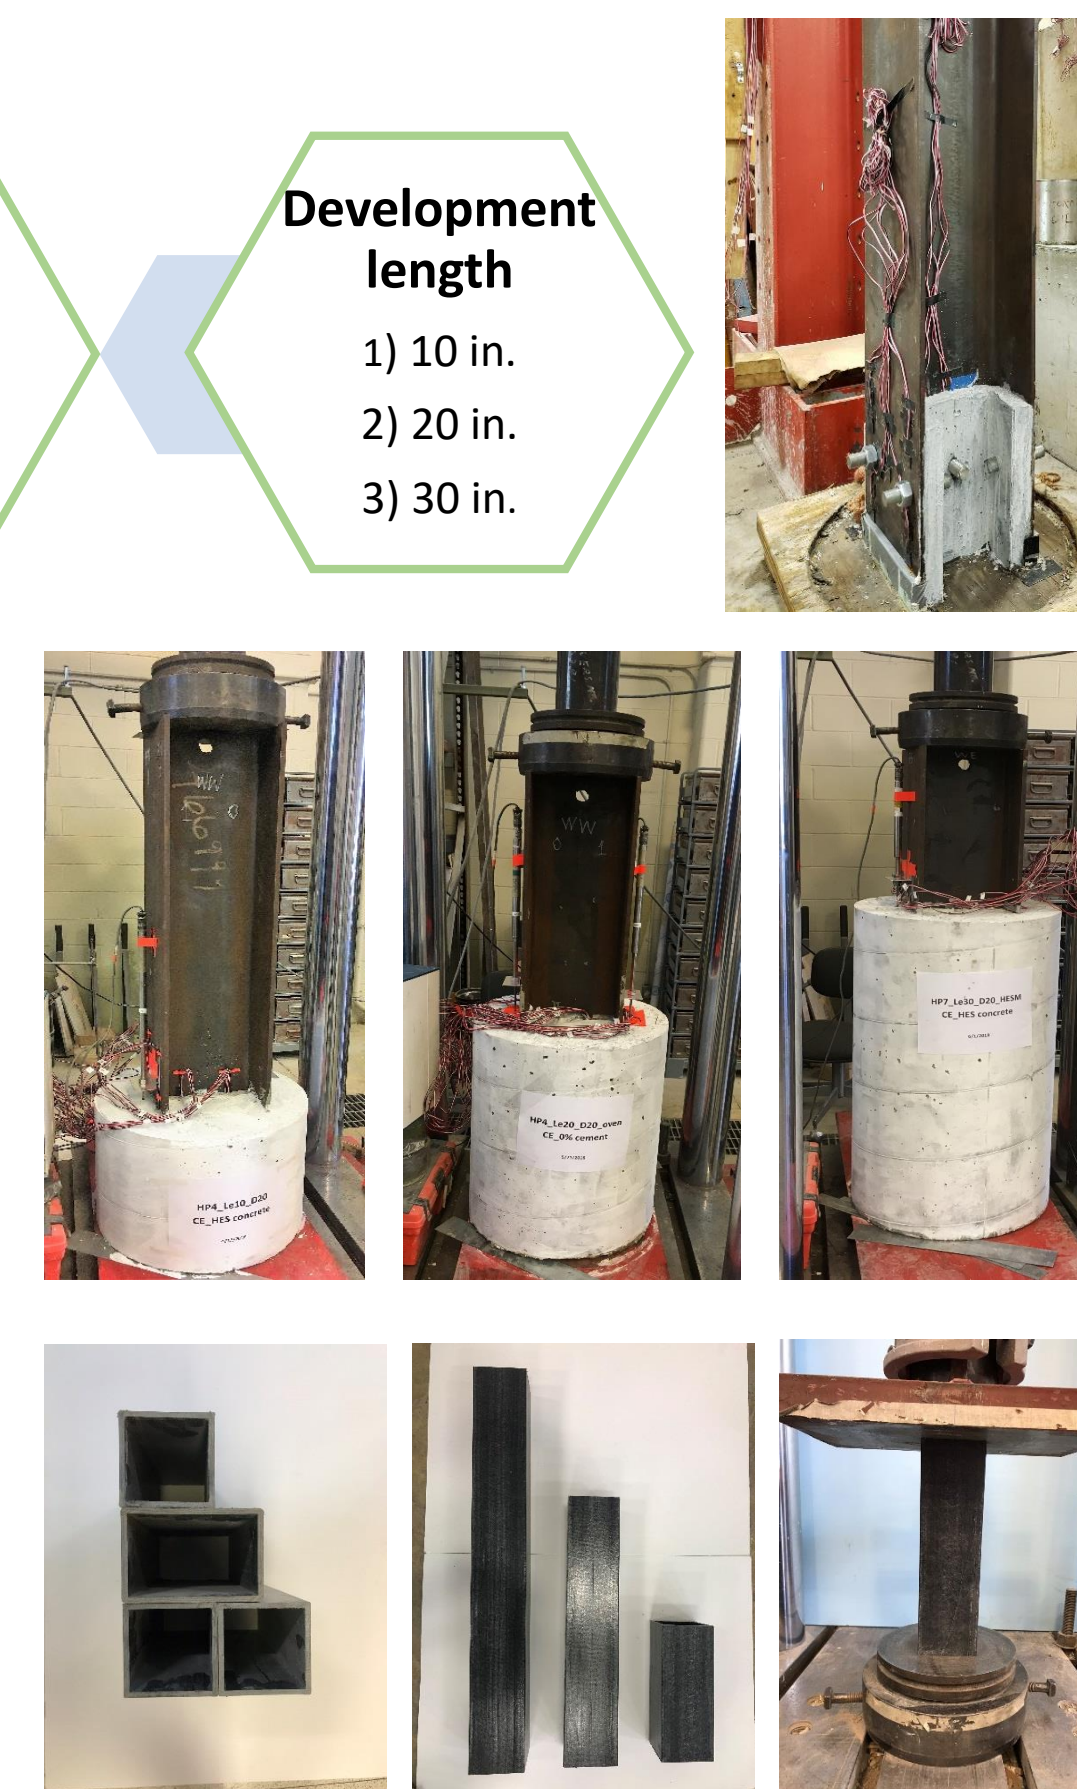
Experimental parameter for the repair methods

Concrete Type

- Conventional concrete
- High strength Concrete

Development length

- 10 in.
- 20 in.
- 30 in.

Number of Dowels

- 4 studs
- 8 studs

FRP layer Thickness

- 0.05 in.
- 0.025 in.
