# Implementing Fiber-Reinforced, Self-Consolidating Concrete as a Repair Material for AASHTO Prestressed Concrete Girders

Jacob Choate, Corey Wirkman, Cameron Murray, Jeffery Volz, & Royce Floyd University of Oklahoma — School of Civil Engineering & Environmental Science

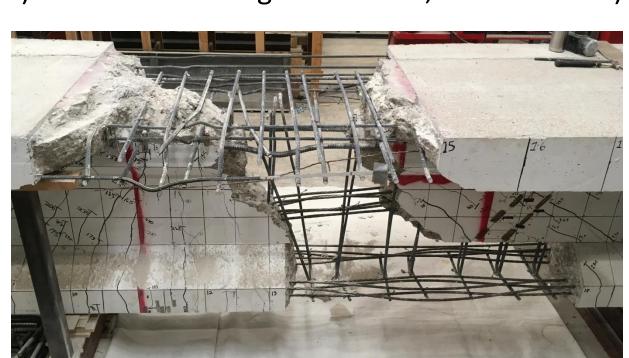
North End During Damage Removal

Repair consisted of three major parts:
1) removal of damaged concrete,

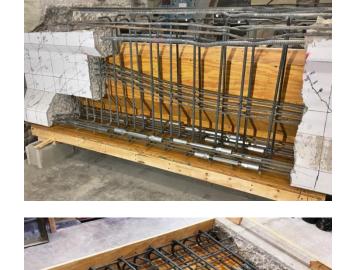
North End Girder & Deck Repair Reinforcing

2) repair/replacement of internal reinforcing, &

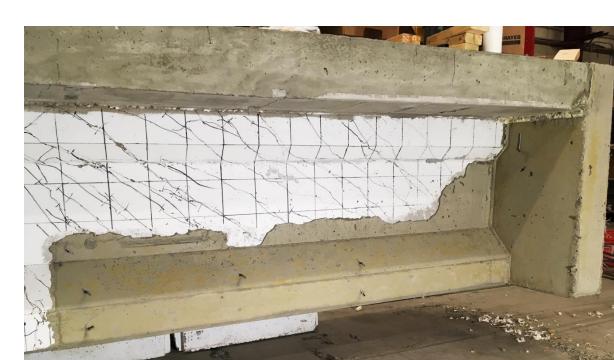
South End Repair After Removing Forms

3) casting the replacing repair material.

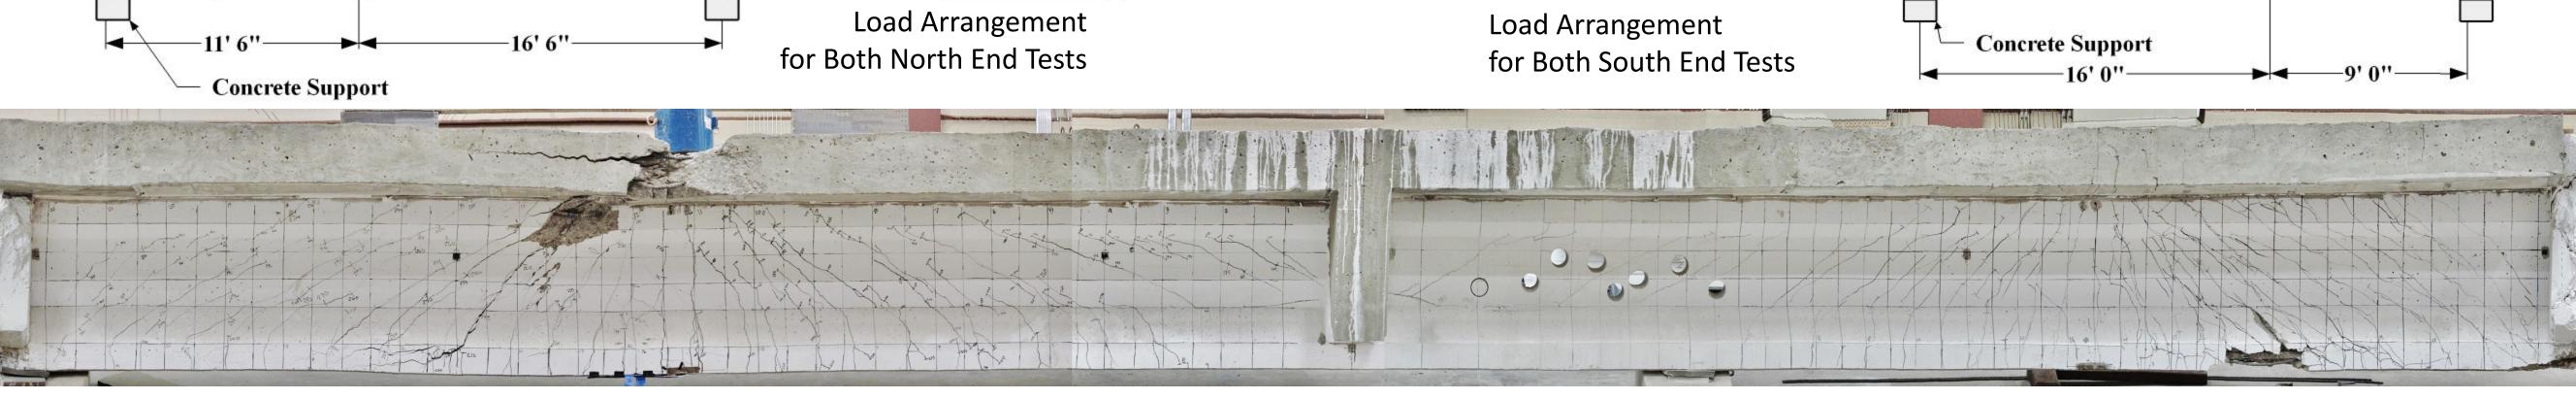
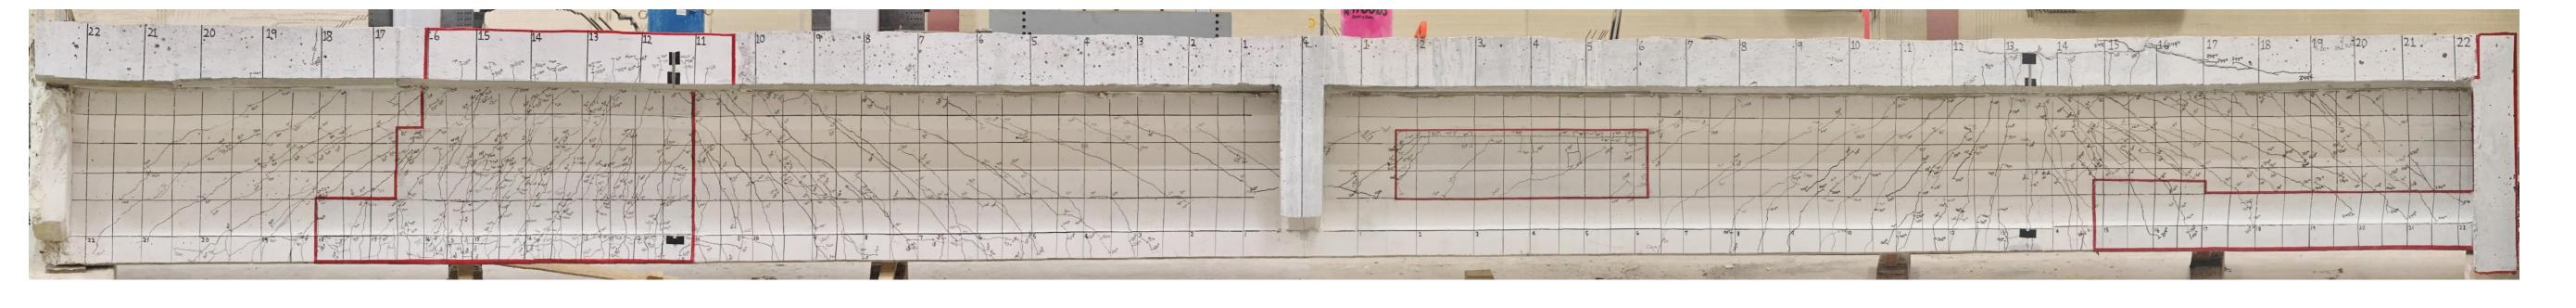
West Elevation of Resulting Damage from Initial Testing (Above) & Resulting Damage from Repair Testing (Below)

The repair tests were able to restore the member to 80% of its original capacities which equates to approximately 175% of the originally intended demand. The initially tested failure mechanisms were shear-based failures; the repair testing failure mechanisms were flexure-based, mitigating the shear failures. Crack propagation of the repair material was evenly dispersed & there were no signs of delamination at the boundaries of the repair.

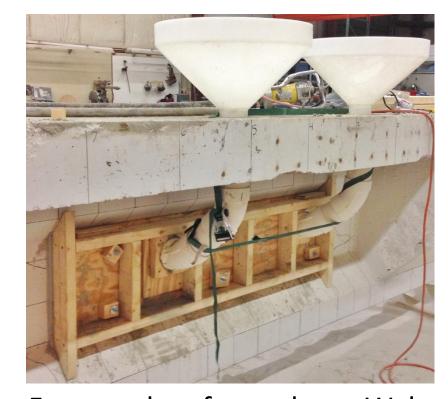
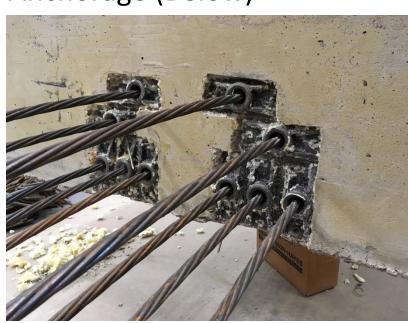
Formwork for the Web Section (Above) & South End Post-Tensioning Anchorage (Below)
