REPAIR EVALUATIONS OF DEPRESSED TRANSVERSE CRACKS IN ASPHALT PAVEMENTS IN DISTRICT 6

FINAL REPORT

ODOT TASK ORDER NUMBER 2160-20-02

August 2021

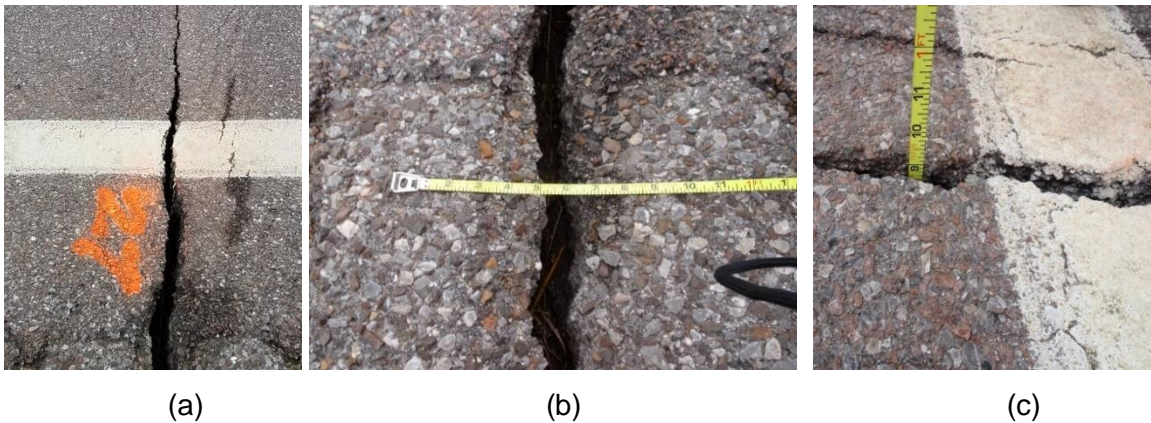
Figure 1.1 Transverse cracks observed in US-270: (a) view from the top; (b) width of crack; and (c) depth of crack

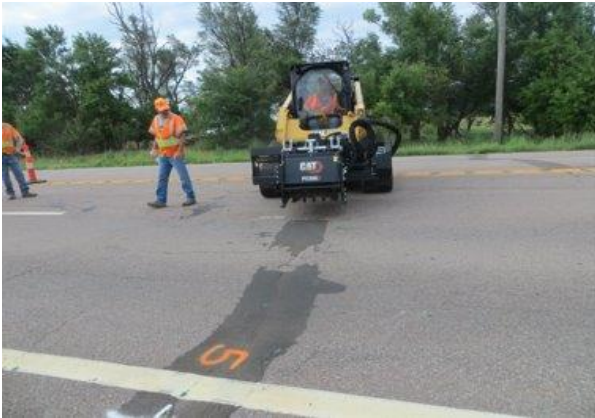
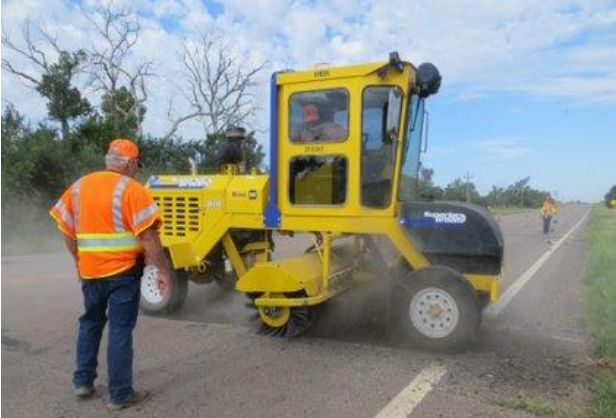
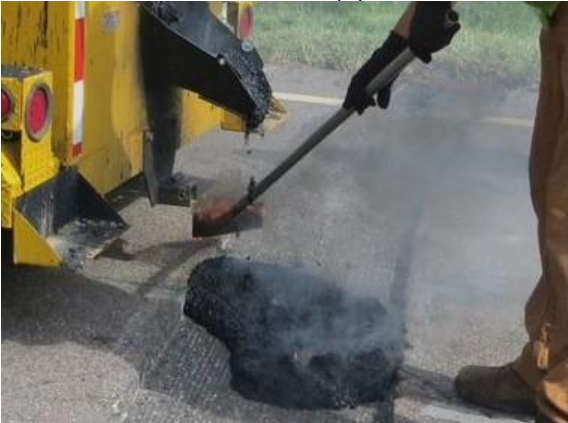
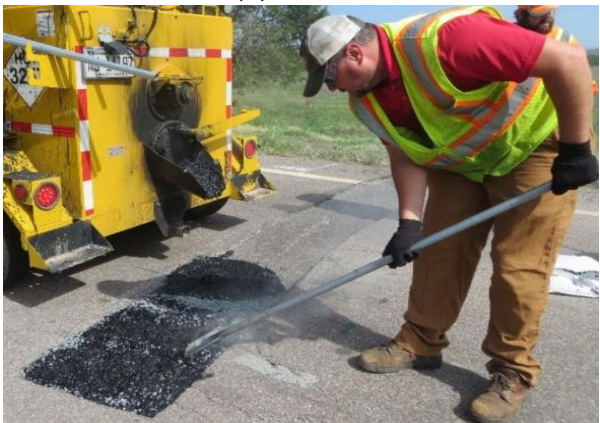
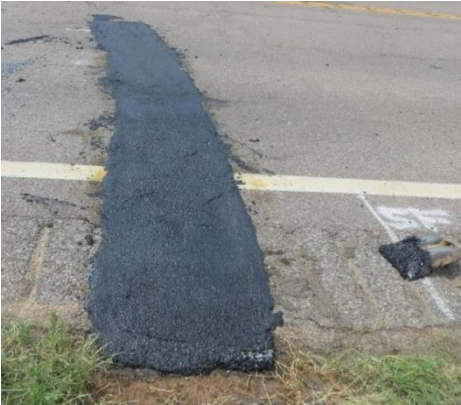
Figure 2.2 Fibrecrete repair at Crack #5: (a) milling; (b) sweeping of dust; (c) laying of Fibrecrete mastic; (d) mixing with aggregate; and (e) final repaired crack

Figures 2.2 and 2.3 show the Fibrecrete and HMA repair activities for Cracks #5 and #12, respectively. Both the Fibrecrete and HMA repairs were performed on July 24, 2020. The east bound lanes of the test section were closed, and traffic control was setup by ODOT to ensure safety during repair activities. For the purpose of the Fibrecrete repairs, the shoulder and the outside lane, along the transverse cracks, were milled to 2-inch deep and 24-inch wide using a milling machine, as shown in Figures 2.2 (a). The milled trench was then swept and cleaned to remove dust (Figure 2.2 (b)). After cleaning, the Fibrecrete material was laid on the milled trench. The material was prepared on the site by a technician from the company (FPTInfrastructure). First, a layer of the heated Fibrecrete mastic was laid on the trench using a shovel (Figure 2.2 (c)). Then, uniformly graded crushed stone chips were spread on the heated Fibrecrete mastic and mixed using the shovel as shown in Figure 2.2 (d). Finally, another layer of heated Fibrecrete mastic was laid on the top. Then the repaired cracks were leveled with respect to the existing pavement using the shovel. No additional compaction was required for the Fibrecrete repair. Figure 2.2 (e) shows the photographic view of the repaired Crack #5. The HMA repairs were conducted with the help of District 6 staff. For HMA repair, similar milling and trenching as Fibrecrete were performed on Cracks #12, #18, and #27. Asphalt mix (S3 HMA with PG 64-22 binder) was collected from a local asphalt plant. The heated HMA was laid in the milled trench using a front-end loader and leveled with shovels (Figure 2.3 (a)). Then the HMA layer was compacted using a hand-operated vibratory compactor as shown in Figure 2.3 (b). Figure 2.3 (c) shows the photographic view of the

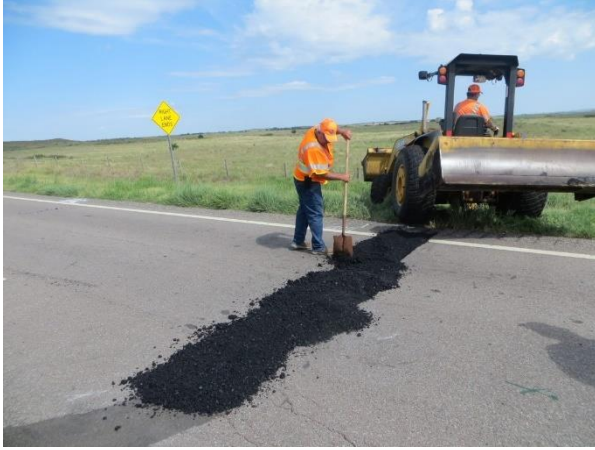
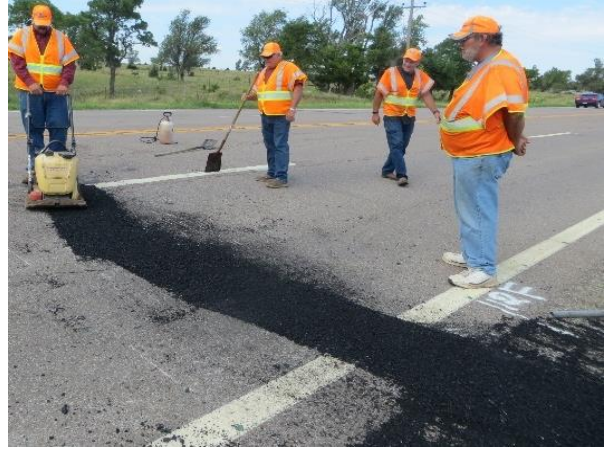
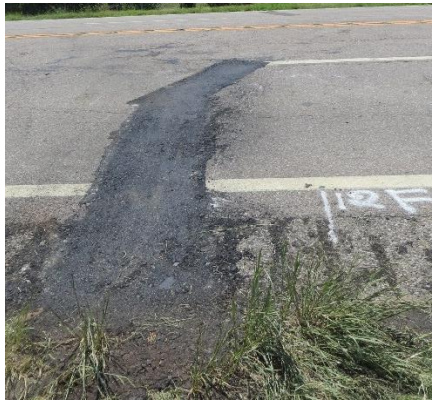
Figure 2.3 HMA repair at Crack #12: (a) laying of HMA; (b) compaction using hand-held compactor; and (c) final repaired crack

repaired Crack #12. The photographs of the crack repair activities for Cracks #7, #9, #18 and #27 are presented in Appendix A.

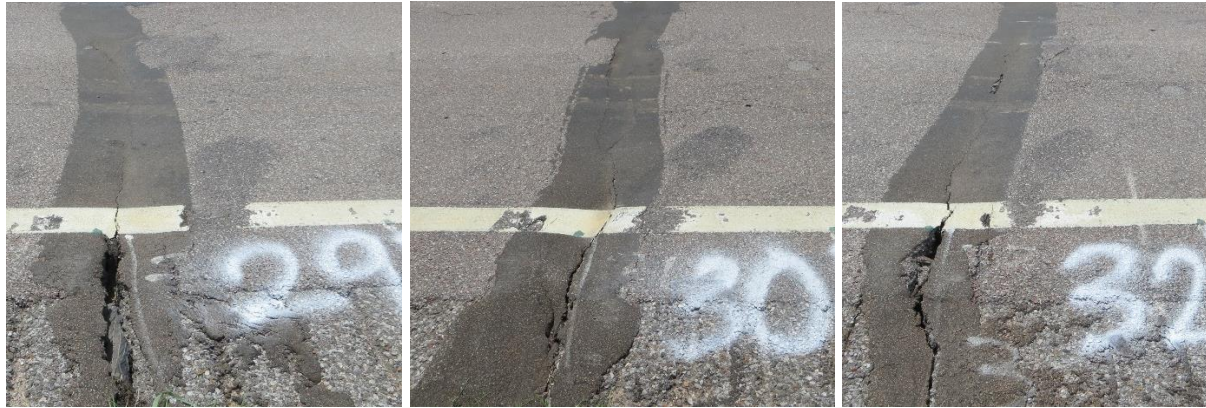
Figures 3.1, 3.2 and 3.3 show the photographs of Fibrecrete-repaired, HMA-repaired and control section, respectively. From physical inspection, the Fibrecrete-repaired sections were found to perform better as compared to HMA-repaired sections. No reflective cracking was observed in the Fibrecrete-repaired sections during after repair evaluations, i.e., Evaluation #2 and #3. However, during Evaluation #3 (11-months after repair), reflective cracks were found in all three HMA-repaired sections, as shown in Figures 3.2 (a), 3.2 (b) and 3.2 (c). Also, cracking along the edges of HMA-repaired sections were observed during Evaluation #3. However, no

significant changes in the crack geometry over time were observed for the control cracks (Figure 3.3).

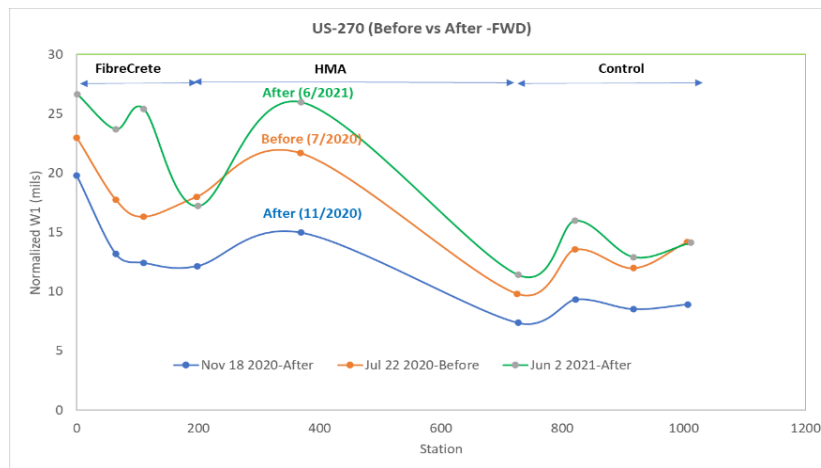
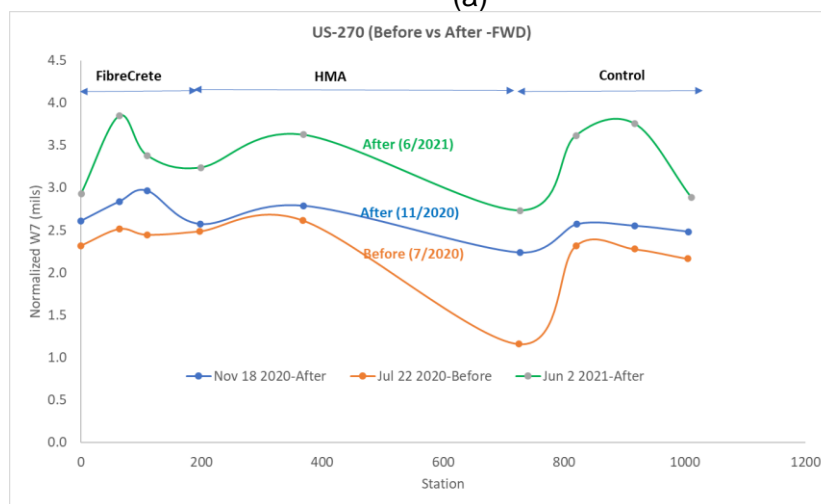
Figures 3.7 (a) and (b) show the variations of normalized (9-kip) deflections for the W1 and W7 sensors, respectively, at the test site for all three evaluations. The W1 sensor shows deflection at the center of the FWD loading plate which represents the overall pavement structural condition at the time of testing. The W7 sensor indicates the deflection at 60 inches from the load center which is an indicator of subgrade strength. The air temperatures during Evaluation #1, #2 and #3 ranged from 96°F to 101°F, 80°F to 81°F, and 80°F to 86°F, respectively. Figure 3.7 (a) shows that the FWD tests near control cracks for all three evaluations exhibited lower W1 deflections than the Fibrecrete- and HMA- repaired sections. The results indicated that the stiffnesses of the control sections were the highest among the three sections. Also, from Figure 3.7 (a), all the FWD tests were found to exhibit lower W1 deflections for Evaluation #2 (4-month after repair) than Evaluation #1 (before repair). Even the control cracked section exhibited lower W1 deflections for Evaluation #2 than Evaluation #1. It was hypothesized that the lower W1 deflections resulted from the lower pavement temperatures during Evaluation #2.

As shown in Figures 3.7 (a) and (b), deflections for both sensors (W1 and W7) collected during Evaluation #3 were higher than those collected during Evaluation #1 and Evaluation #2. It was believed that the presence of higher moisture content in the base and subgrade layers was responsible for these higher deflections. There were almost three-week of continuous rains before the Evaluation #3 on June 2, 2021. During the evaluation, pools of standing water were

observed in areas with ruts. Although, the temperature during data collection was slightly higher for Evaluation #3 than Evaluation #2, the higher moisture contents of the base and subgrade layers were believed to be the primary contributor for the higher W1 deflections during Evaluation #3.

Figure 3.7 Variation of normalized (a) W1; and (b) W7 deflections with FWD stations

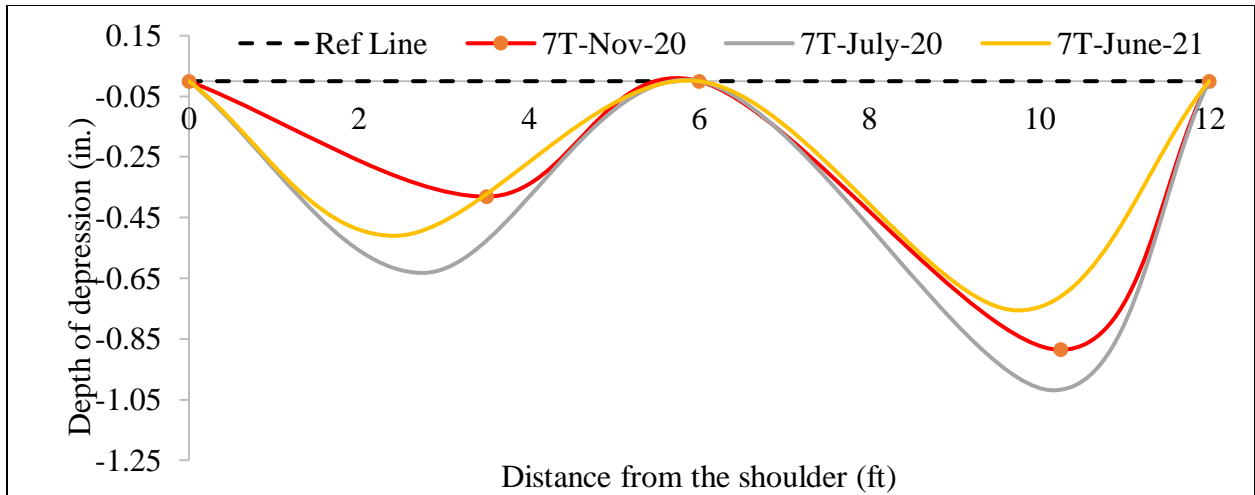
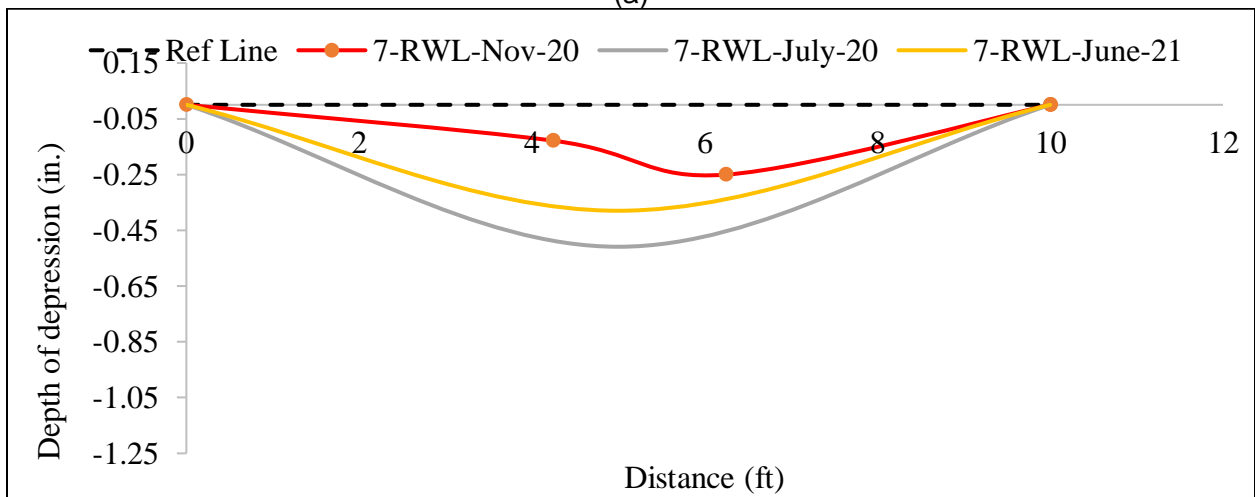
Figures 3.9, 3.10 and 3.11 show the transverse and longitudinal (right and left wheel paths) profiles of Crack #7 (Fibrecrete-repaired), #18 (HMA-repaired) and #32 (control), respectively. The profiles of all the cracks can be found in Appendix D. By comparing the straightedge measurements of different sections, it was found that the Fibrecrete-repaired sections performed well as compared to the HMA-repaired and control sections. Deflections or depressions in both transverse and longitudinal directions were found to decrease after repairing with Fibrecrete, as evident in Figures 3.9 (a), (b) and (c). However, as shown in Figure 3.10 (a), with time, the surface deflections in the transvers direction increased for the HMA-repaired section. Also, deflections for the control sections were not found to change significantly after 11-months of repair, as shown in Figure 3.11.

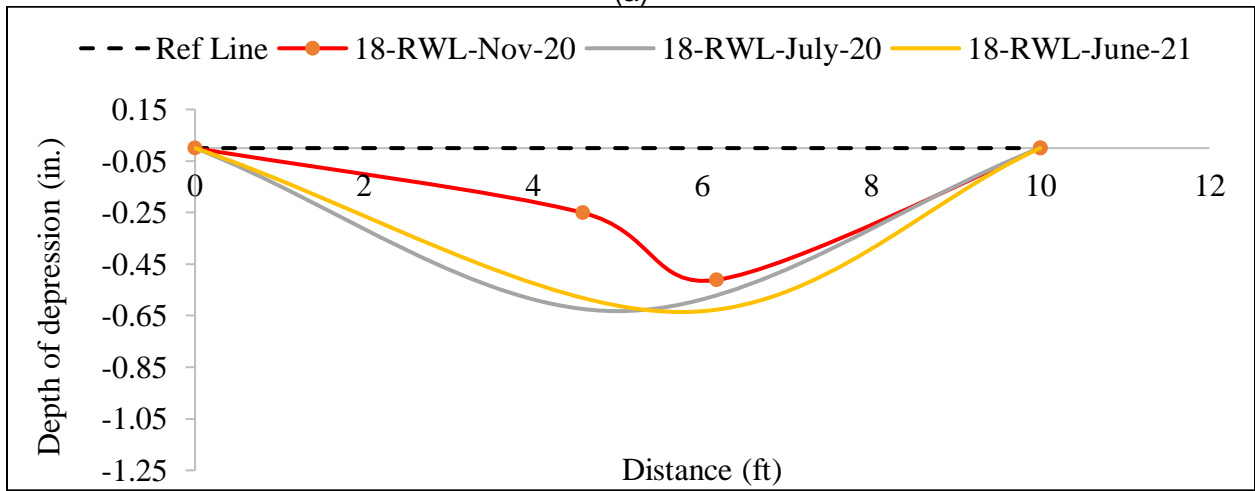
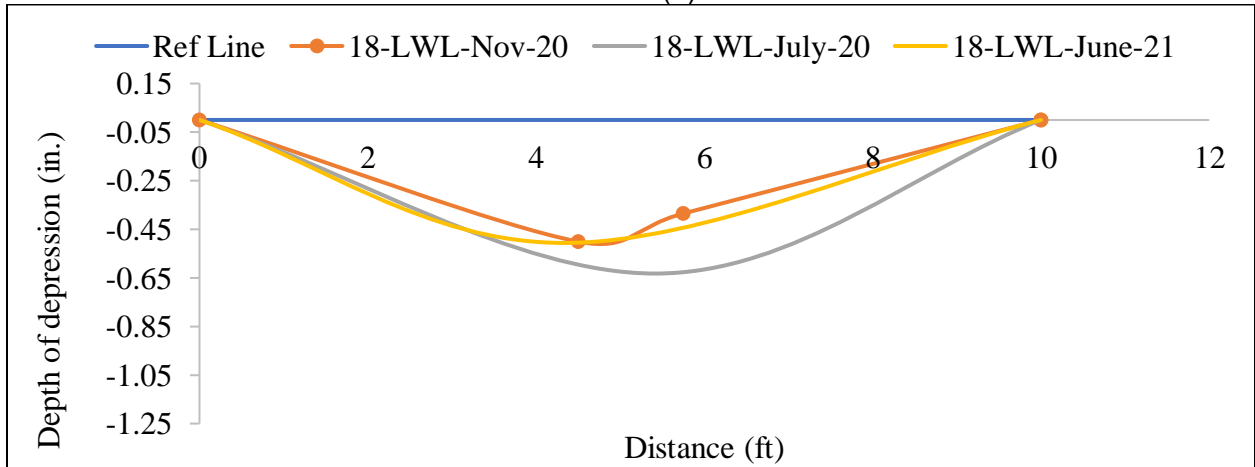
Figure 3.10 Straightedge results at Crack #18: (a) transverse profile; (b) longitudinal profile along right wheel-path; and (c) longitudinal profile along left wheel-path

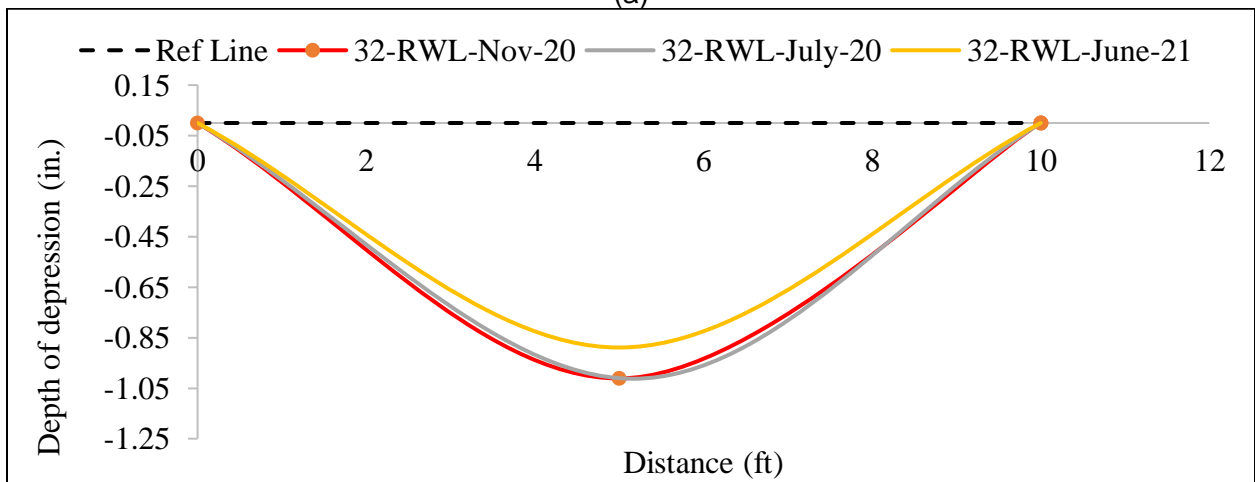
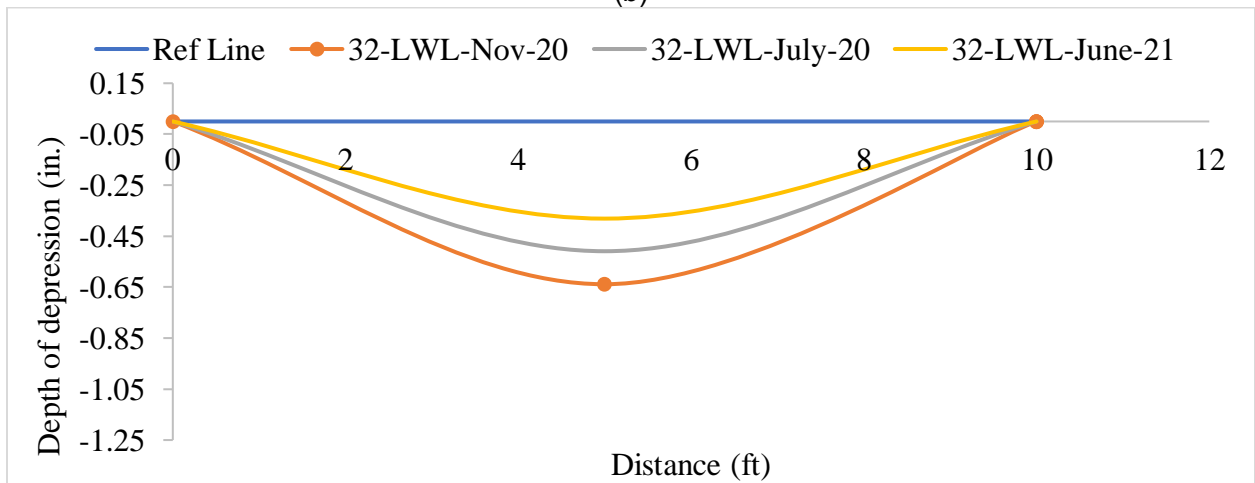
Figure 3.11 Straightedge results at Section #32: (a) transverse profile; (b) longitudinal profile along right wheel path; and (c) longitudinal profile along left wheel path

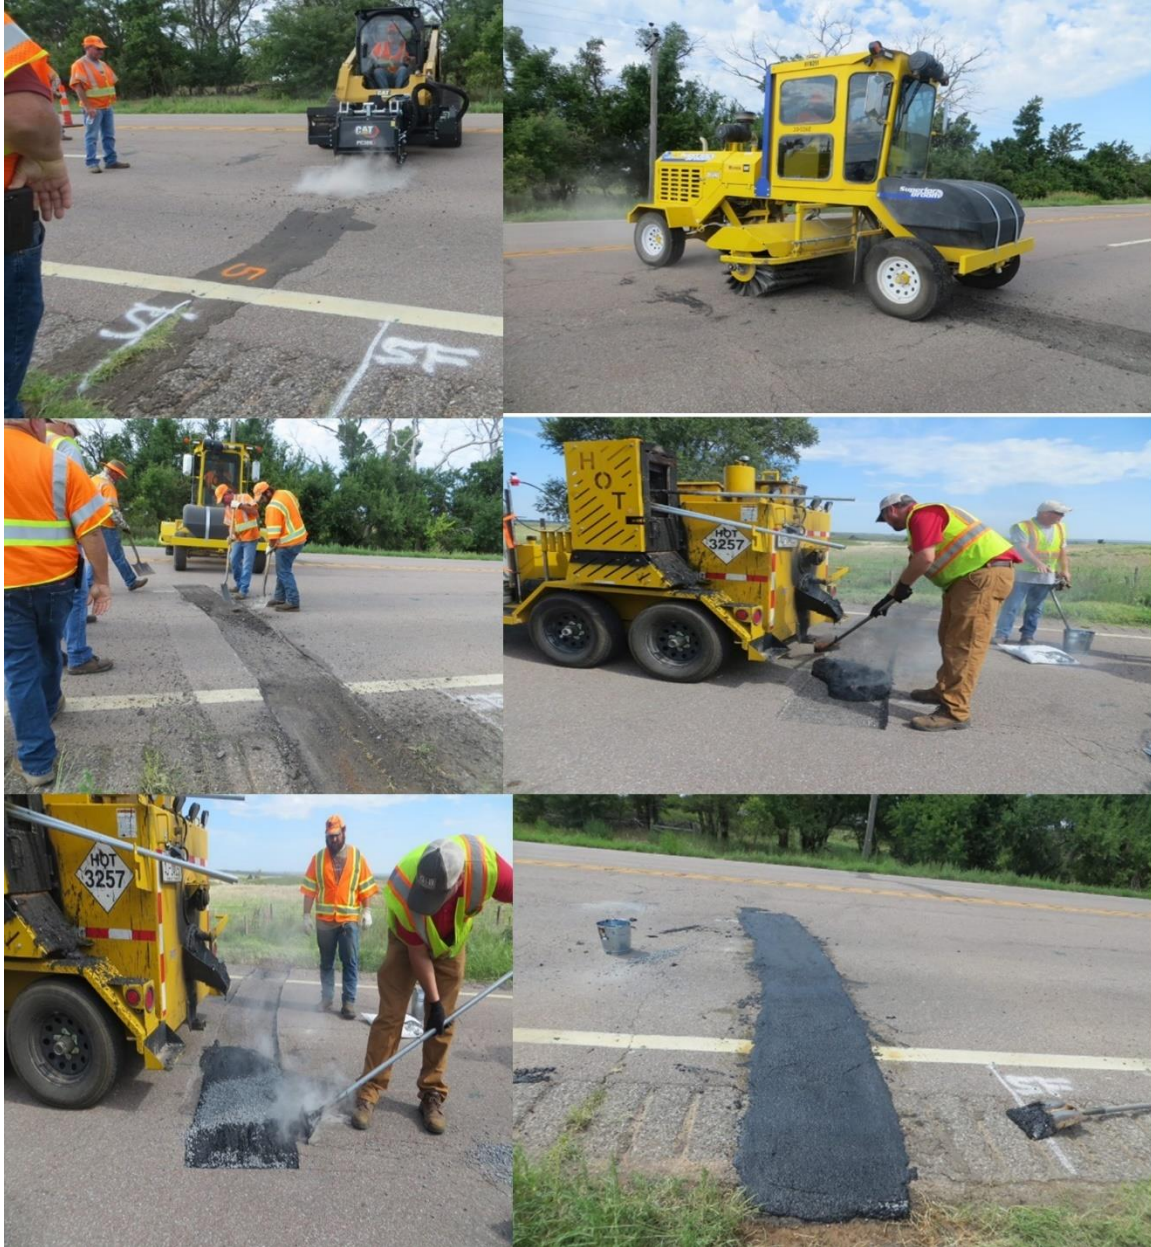
Figure A.1 Repair Activities of Crack #5

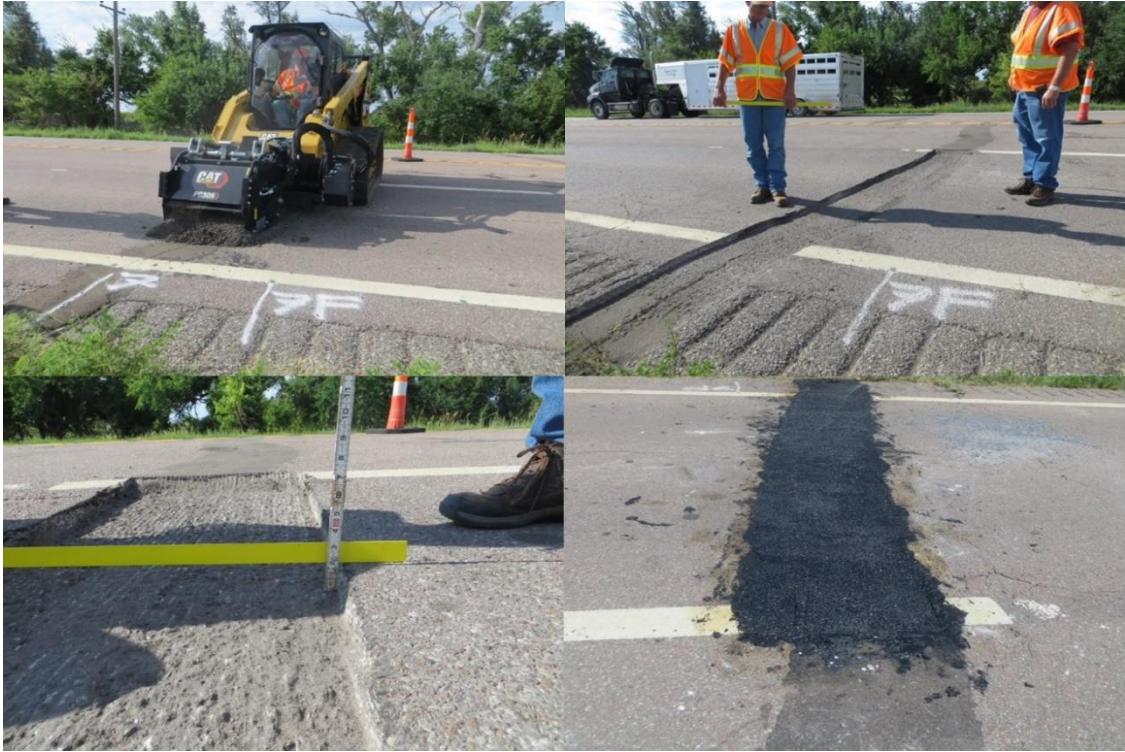
Figure A.2 Repair Activities of Crack #7

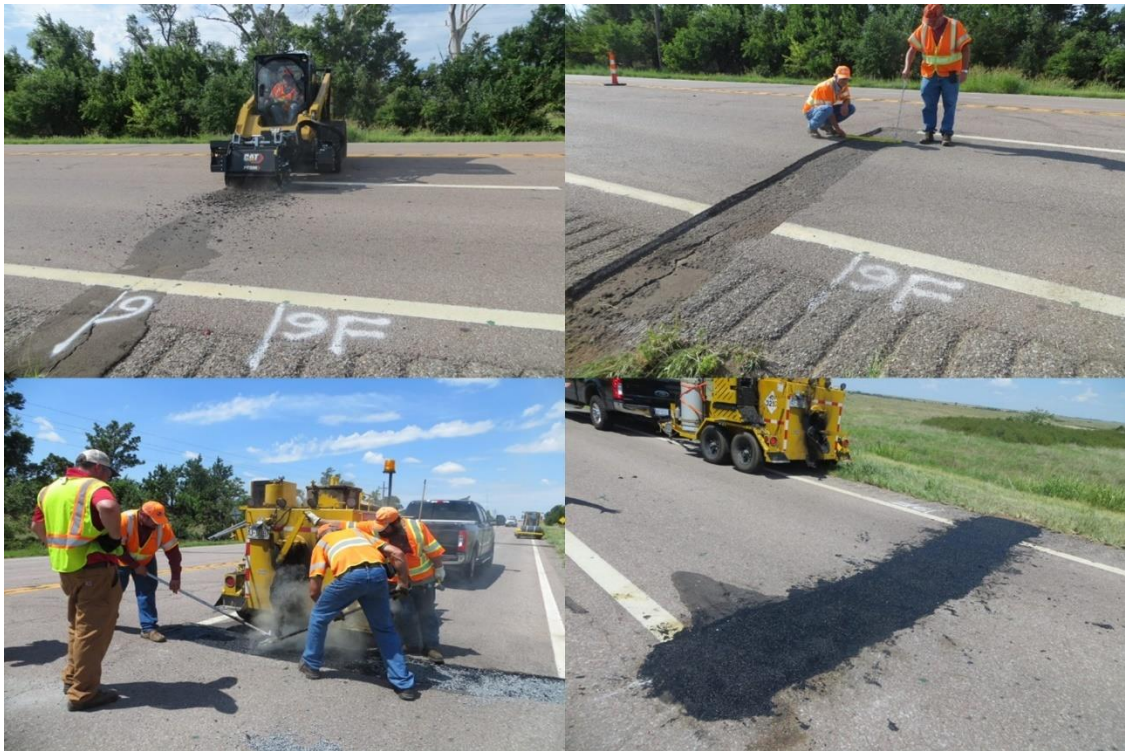
Figure A.3 Repair Activities of Crack #9

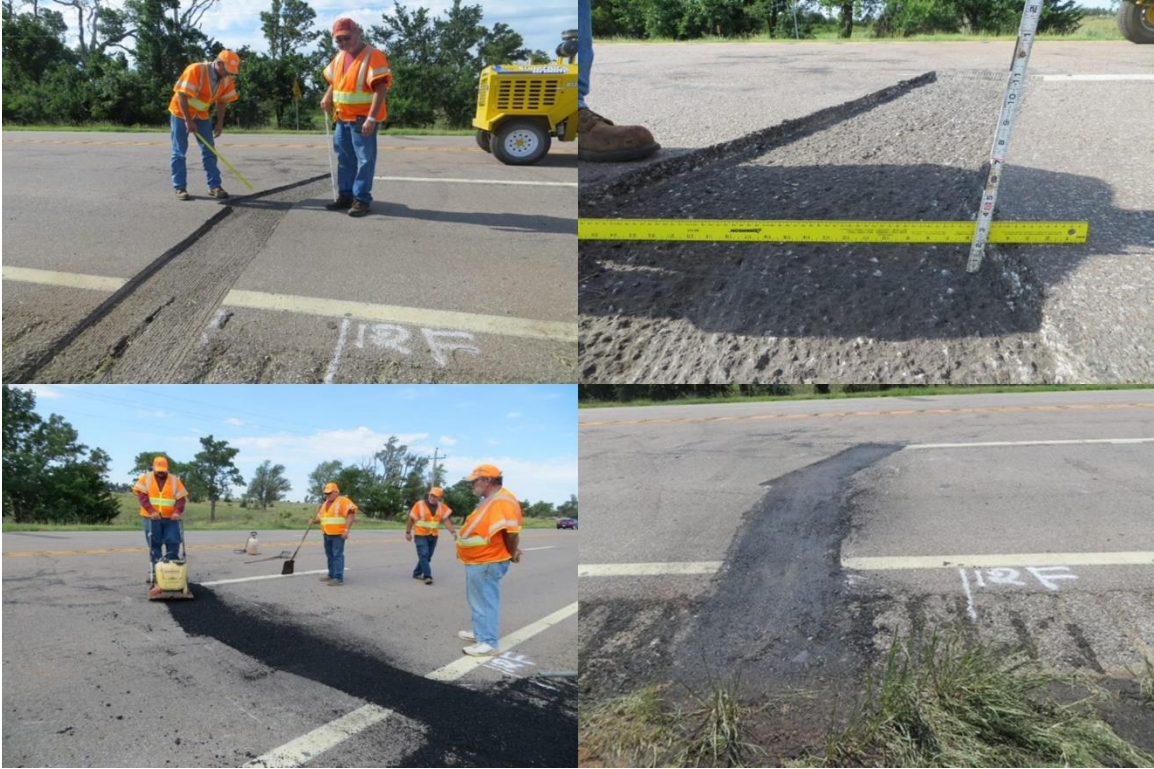
Figure A.4 Repair Activities of Crack #12

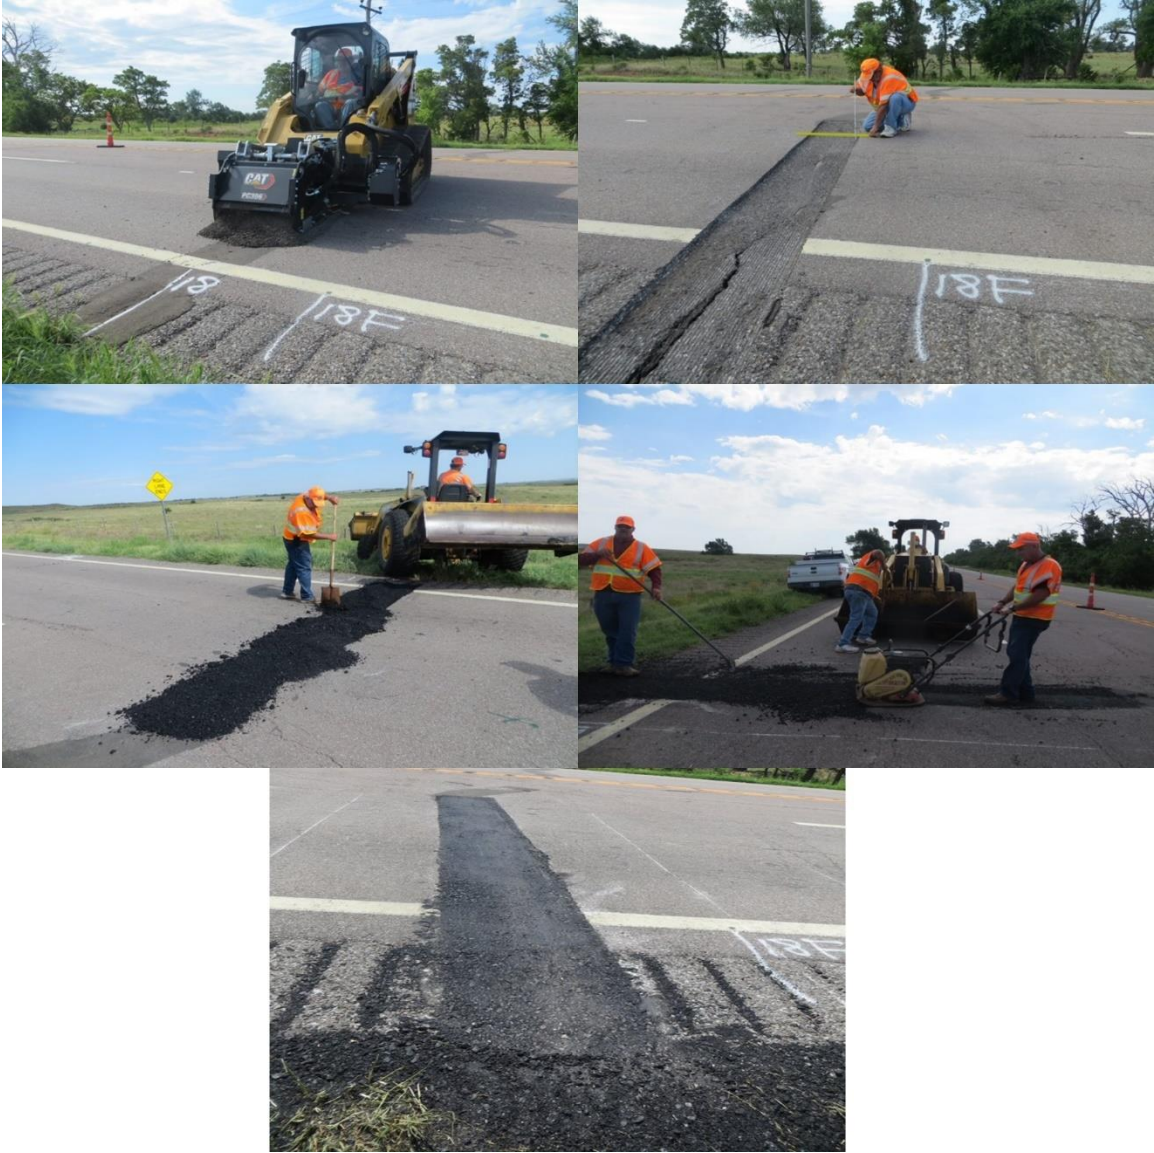
Figure A.5 Repair Activities of Section #18

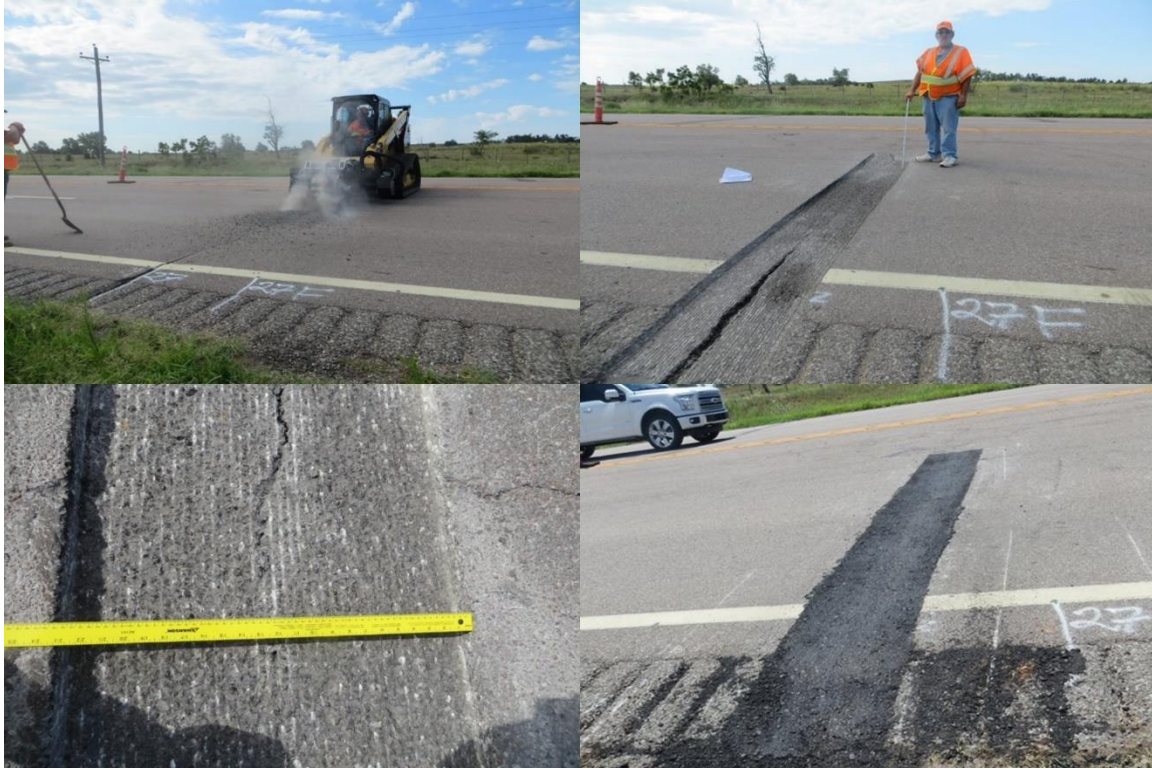
Figure A.6 Repair Activities of Crack #27
